Muddy River Flood Risk Management & Environmental Restoration Project
Phase 1 Construction Activities Next 90 Days
June 2015

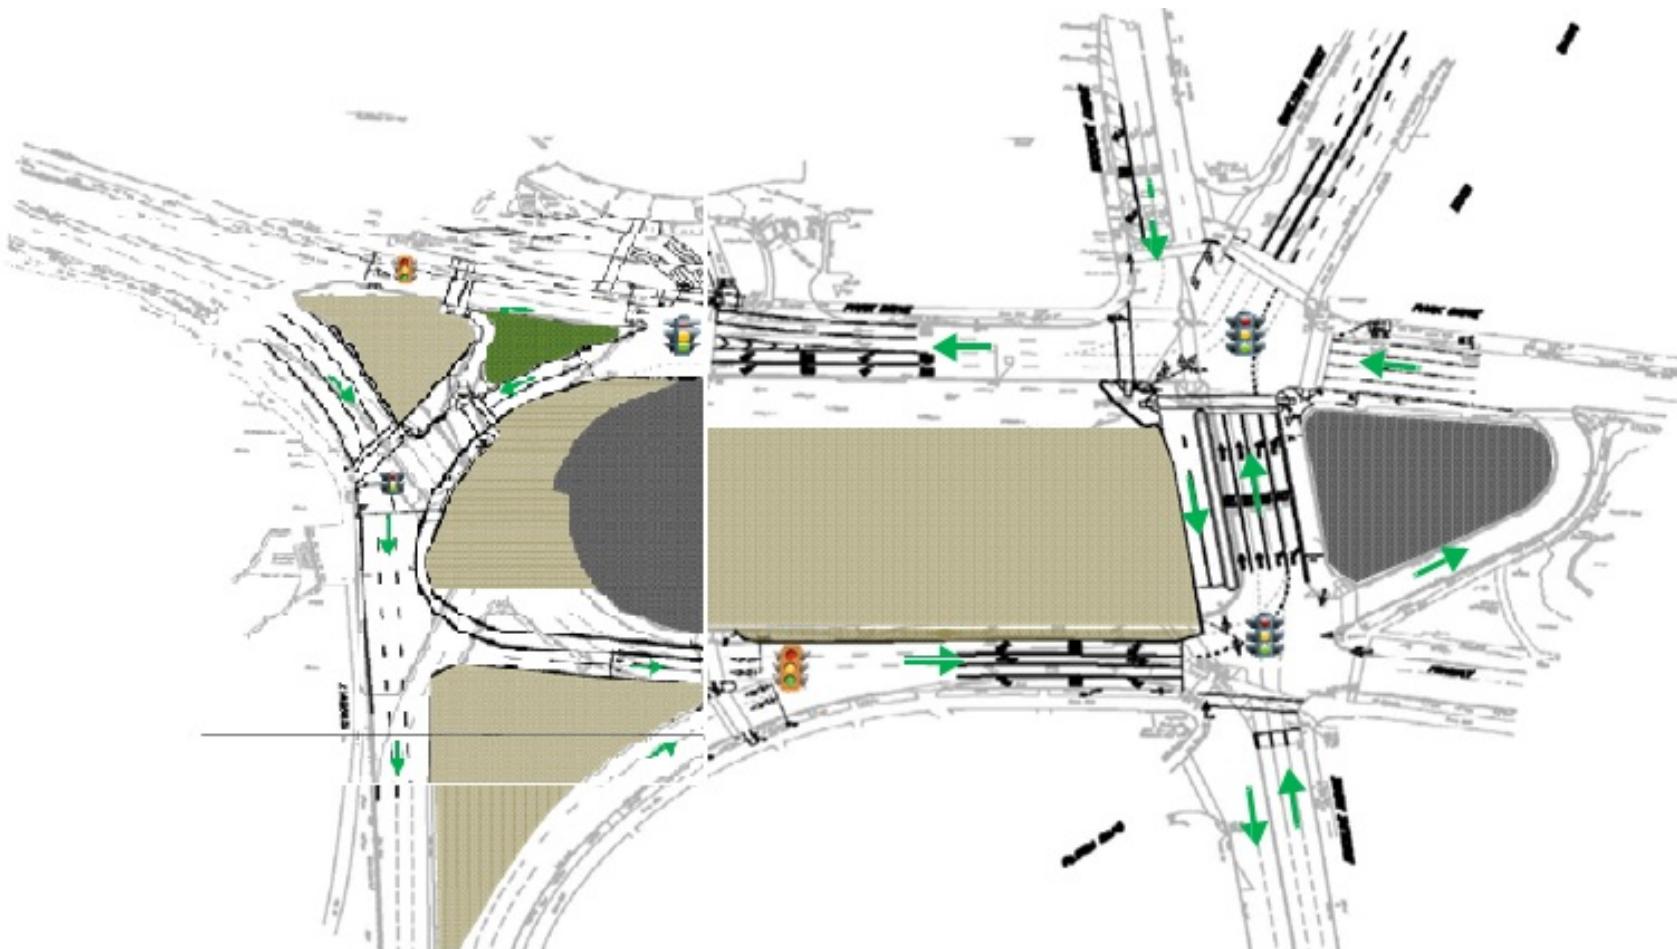
TRAFFIC MANAGEMENT PLAN DURING SECOND PHASE OF RIVERWAY CULVERT INSTALLATION AND THE CREATION OF THE NEW WALKWAY AT PARK DRIVE ISLAND

- In order to continue the work on the Riverway Culvert, a traffic shift was performed on April 25 and 26, 2015. This traffic shift maintained the current traffic pattern around the former Sears Parking Lot at Park Drive, between the Landmark Center and the Riverway Connector, but funneled the three lanes of traffic down to two lanes as it rounds the former Sears Parking Lot and connects with the Riverway Connector. In addition, Brookline Avenue was opened back up to two-way traffic to alleviate any potential congestion caused by the Park Drive lane reductions. The current traffic pattern can be seen in the figure shown below.

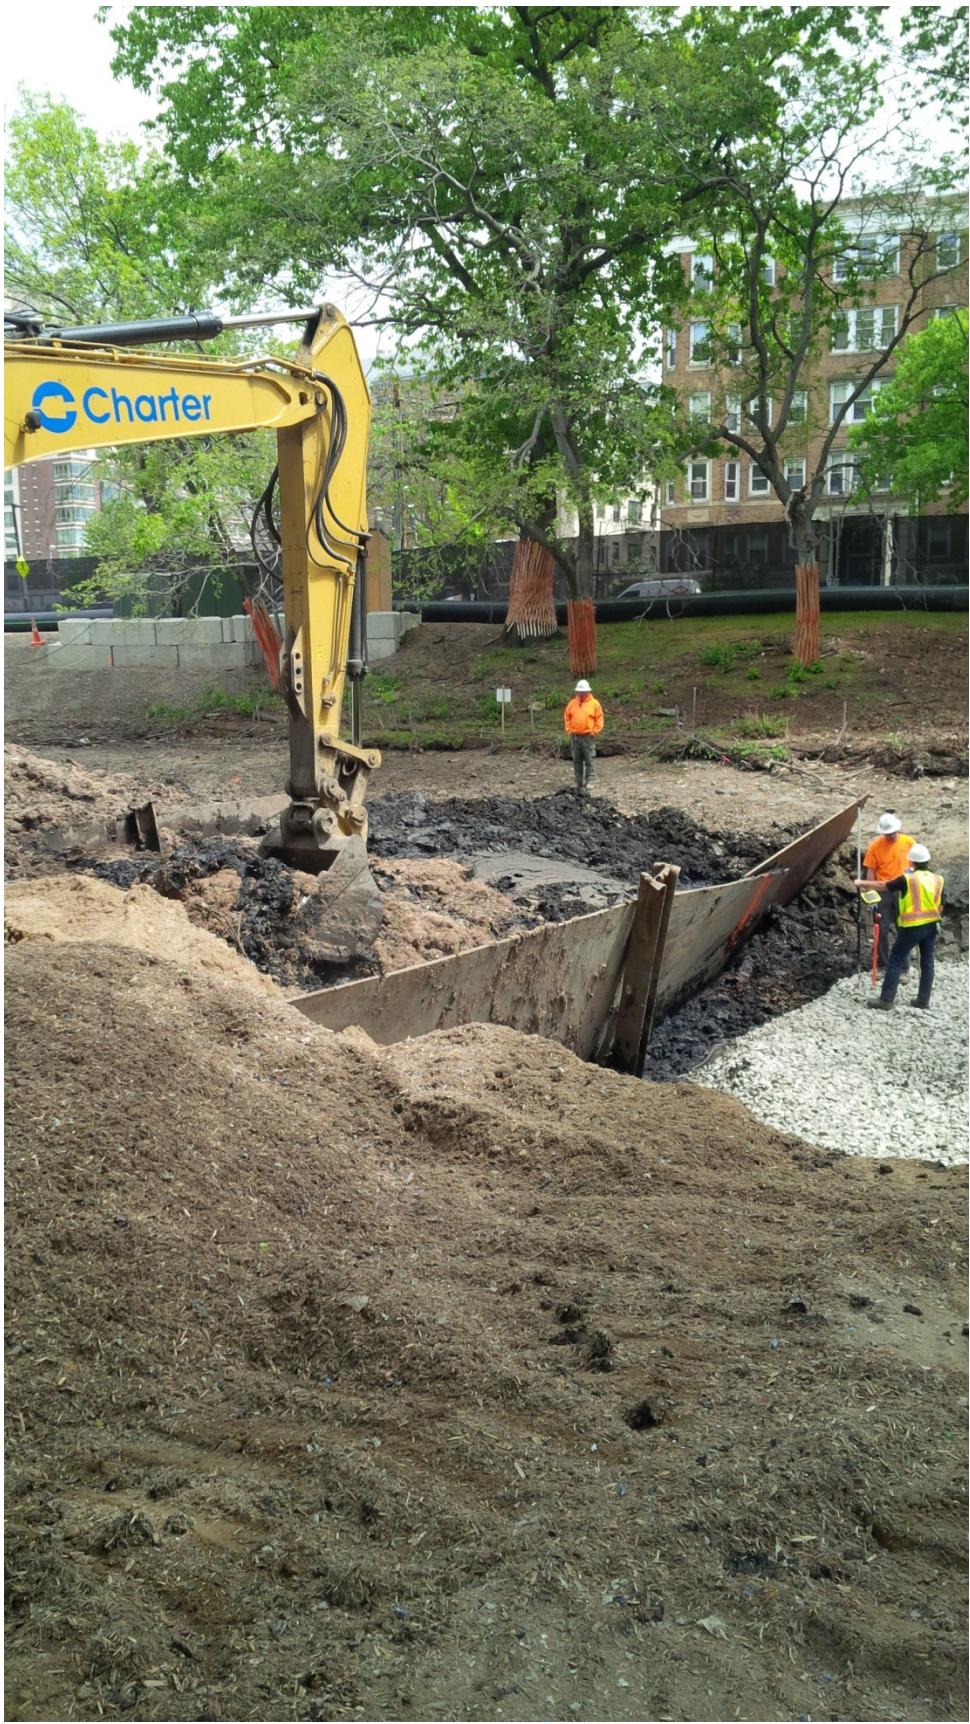
Continued removal of sediment from channel bottom of the Upper Fens Pond – mid May 2015.

- A concurrent activity to the Riverway culvert and end condition roadway lighting work is the sediment removal and bank restoration/stabilization of the Upper Fens Pond. Since the active diversion of the river began in mid-April, the removal of the sediment in the river bottom to construct the new flood risk management channel in the Upper Fens Pond has been completed. Currently, the contractor is restoring/stabilizing the banks on both sides of the channel with stone protection. On the upland part of the banks, additional bank stabilization with geocells will begin. Bank construction will continue into August.

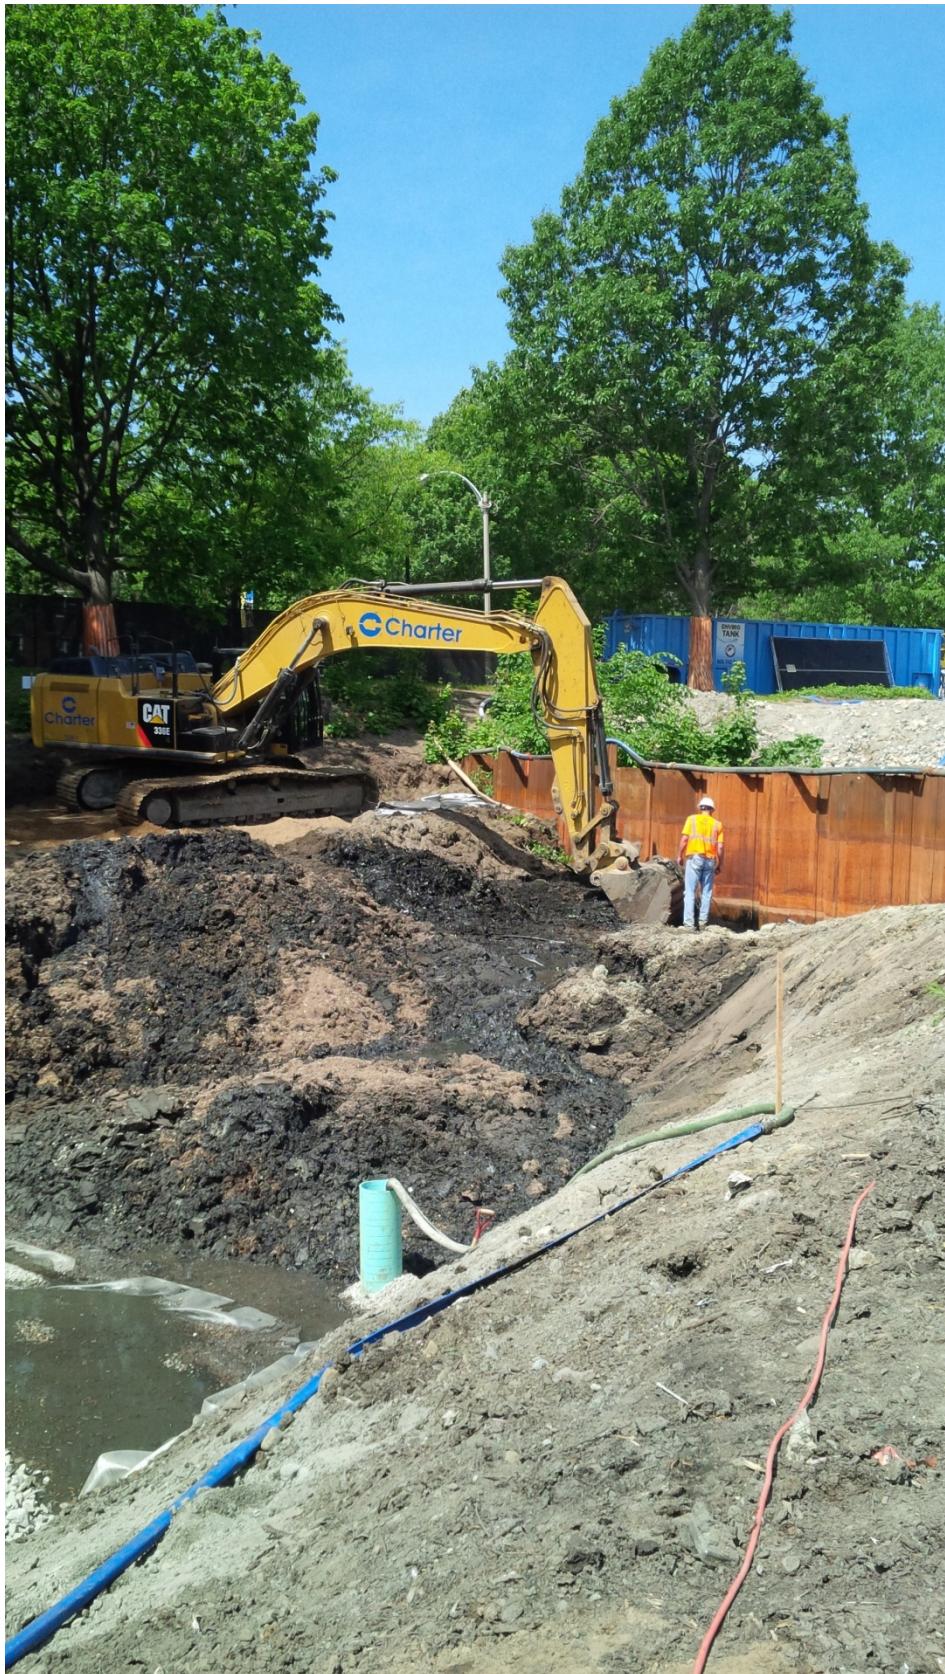
Removal of the last of the sediment from channel bottom of the Upper Fens Pond – end May 2015.

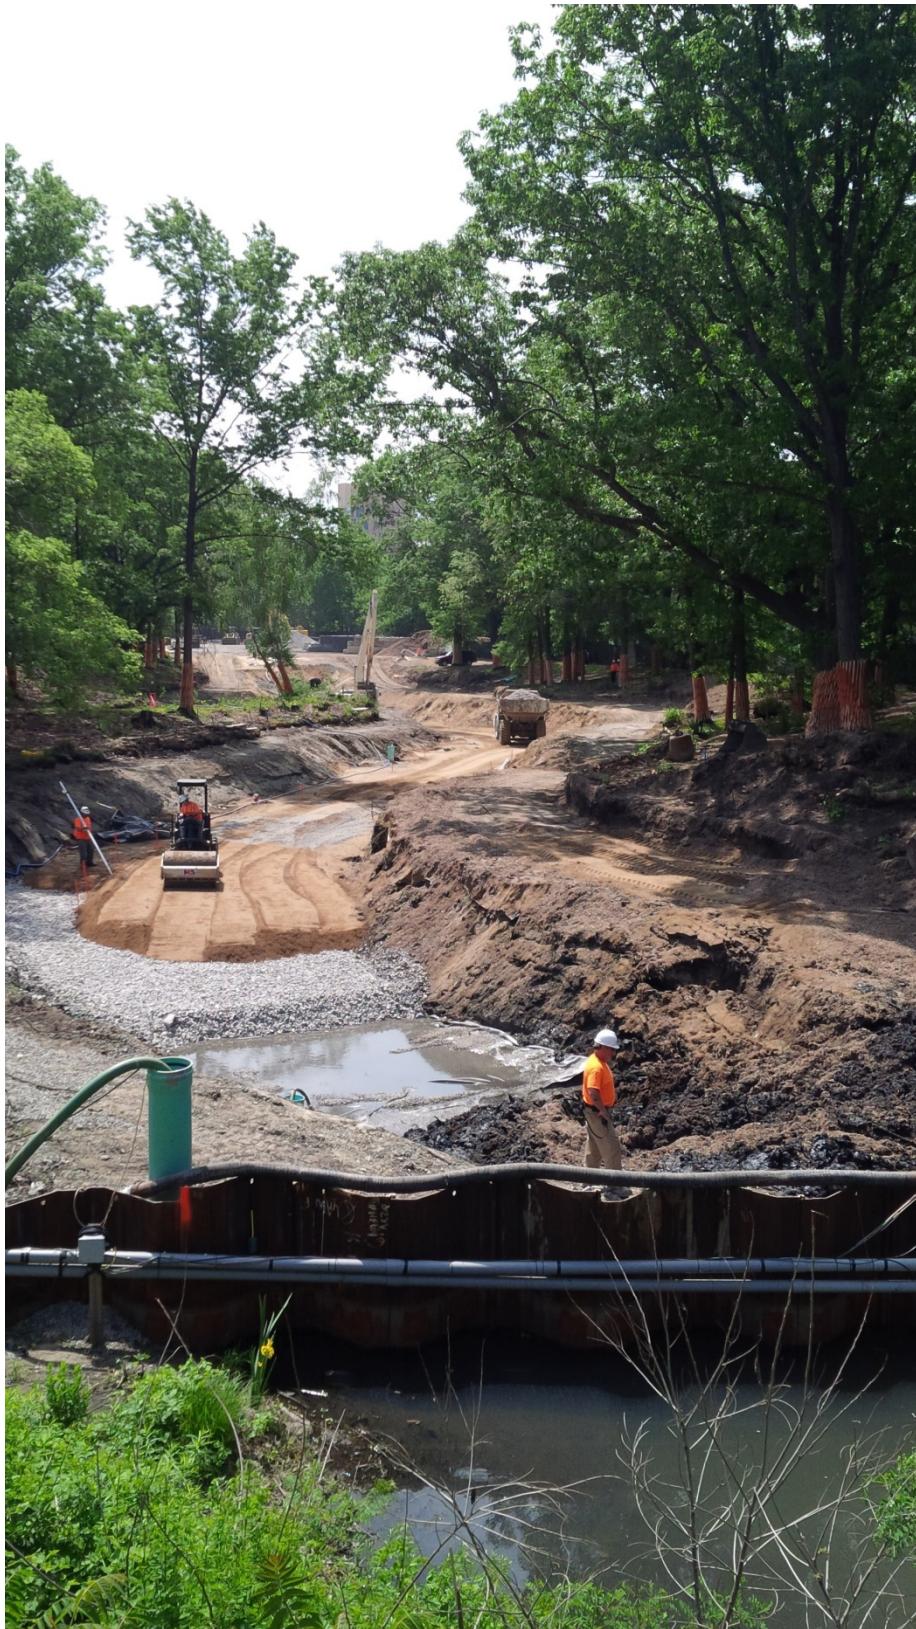
Looking downstream at Upper Fens Pond. Note the new river channel taking shape and the last of the sediment to be removed near the right bank – end May 2015.

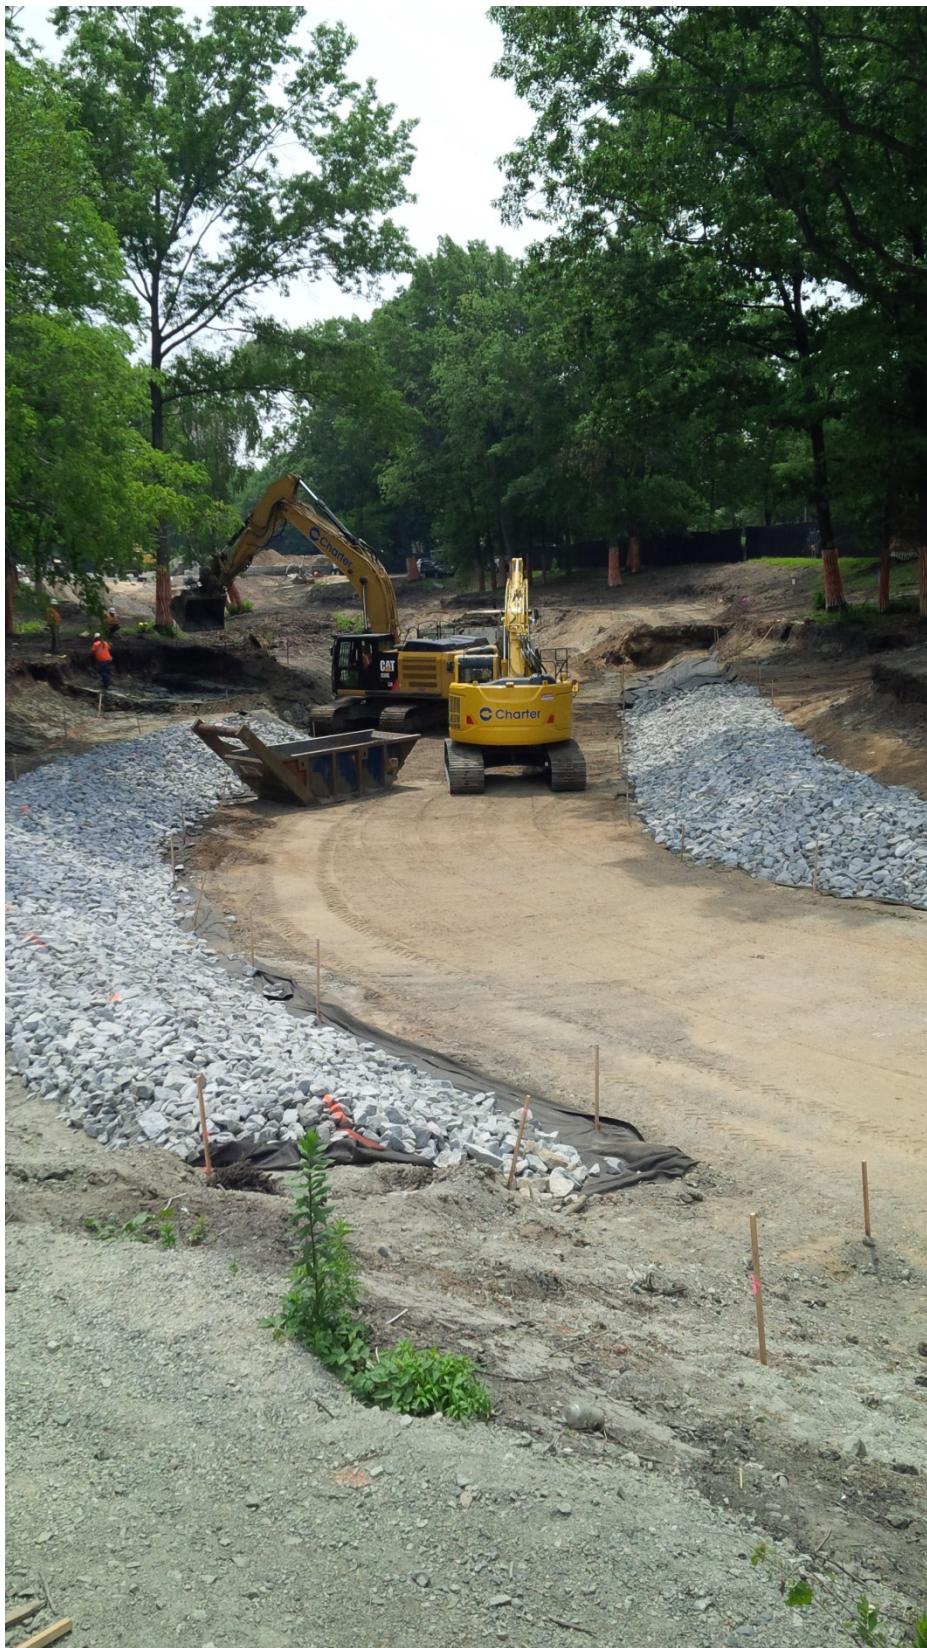
Looking downstream at Upper Fens Pond. Note the new river channel and the construction of the slope protection/bank stabilization at the toe of the bank – early June 2015.

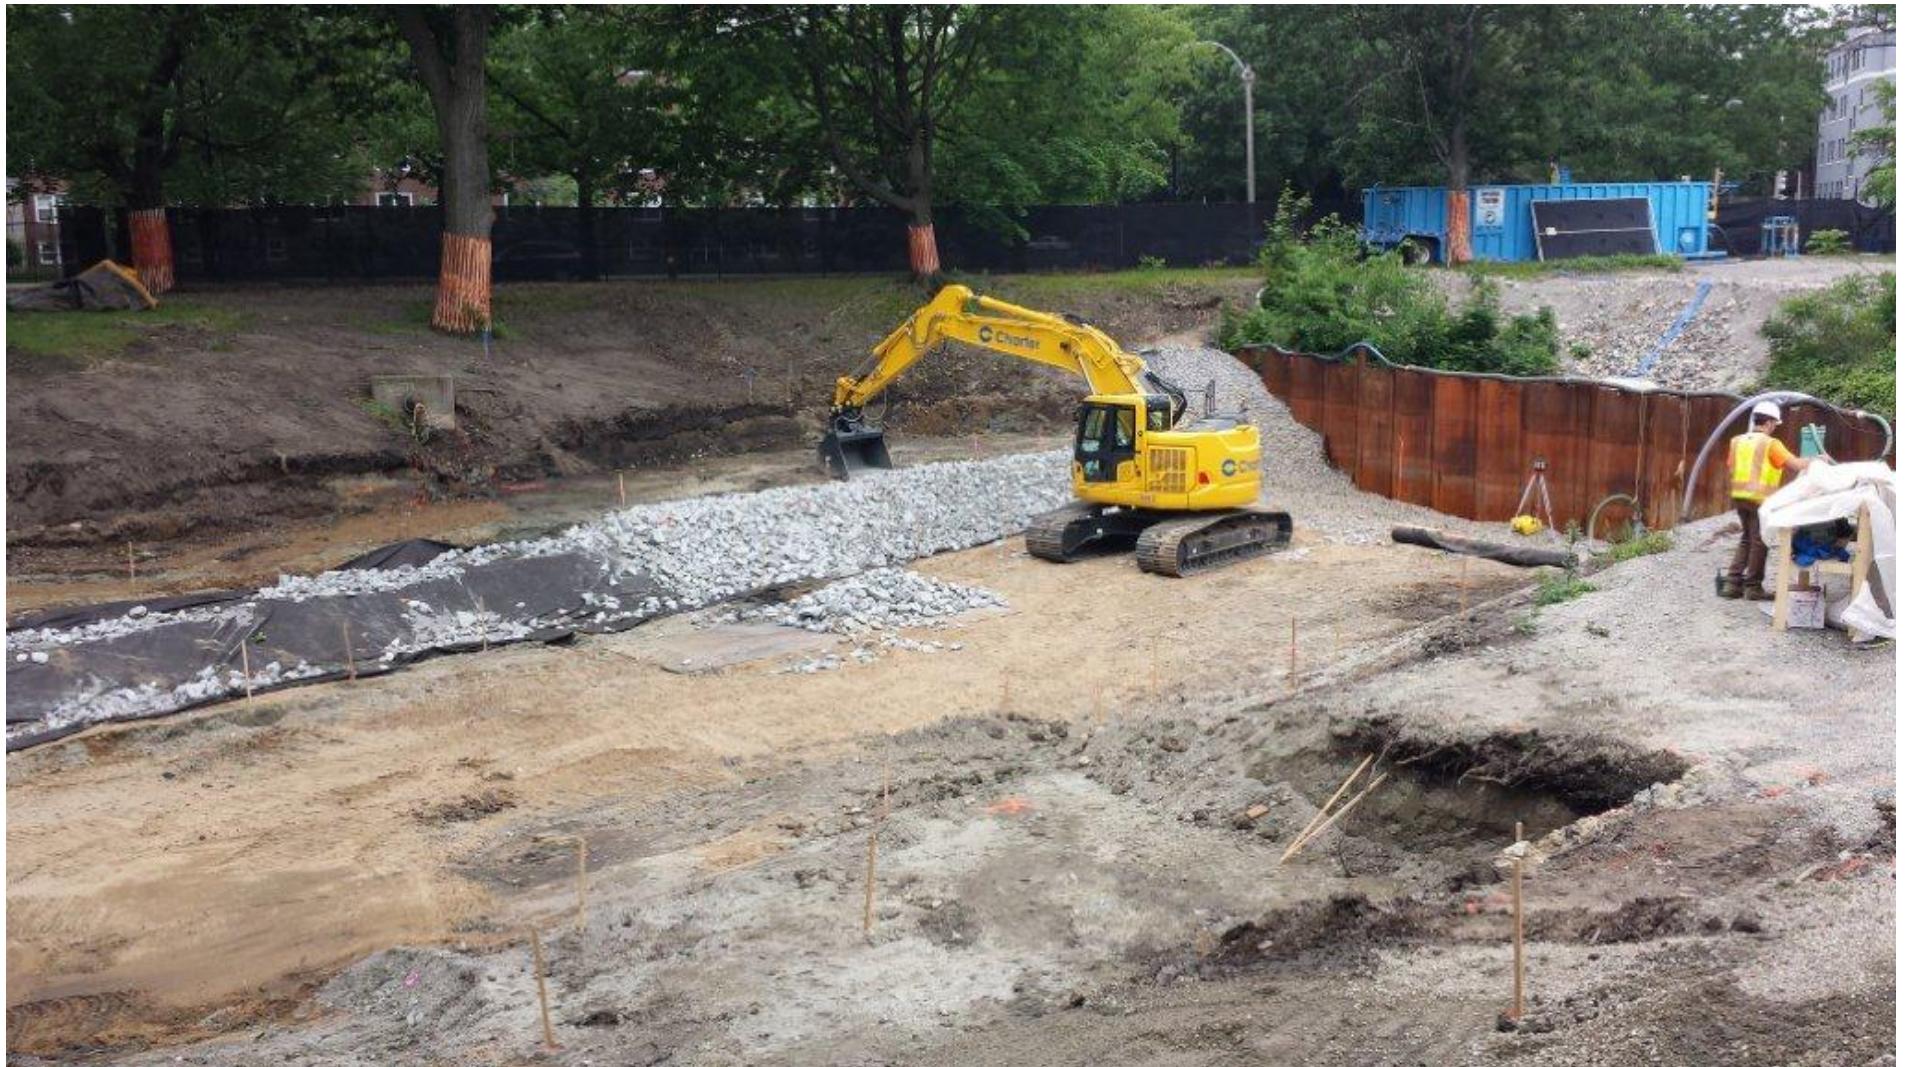
Bank stabilization/construction with stone protection at Upper Fens Pond – early June 2015.

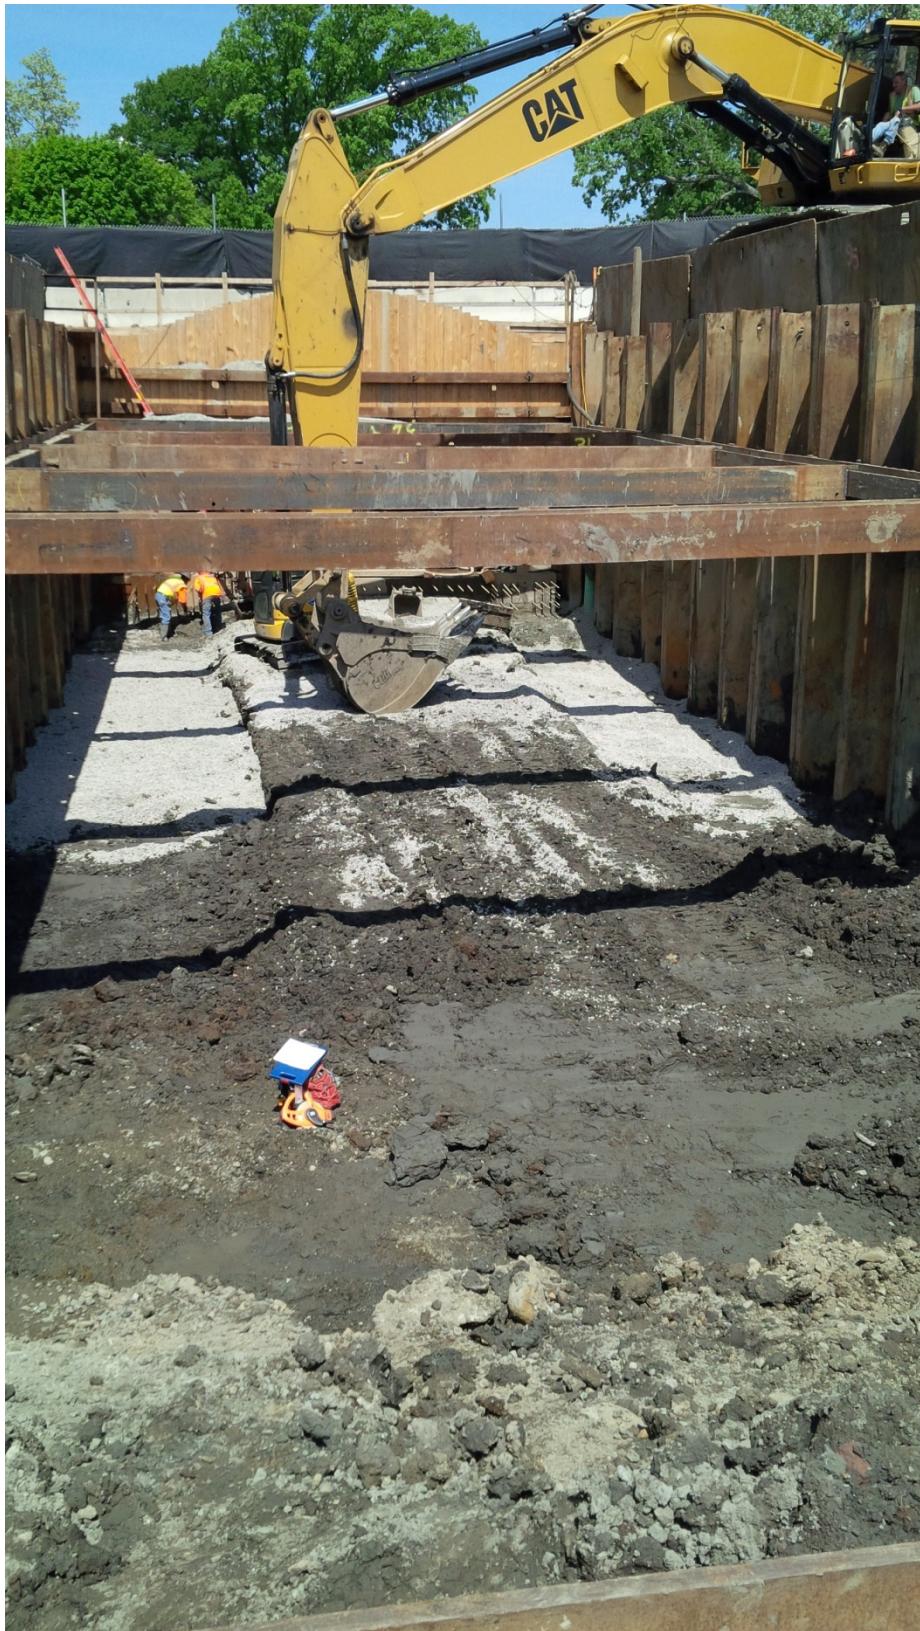
Excavation to top of pile cap grade at the Riverway culvert work area – end May 2015.

- In the Riverway Culvert work area, since the traffic move, the contractor has excavated to grade of the pile caps and has begun installation of steel pipe piles. The vibrating of the pipe piles began in early June and it is expected to be complete before the end of June. Once the pipe piles are in, then the next activities will be tying steel and formwork, in preparation for concrete placement for pile caps; invert slab; and wing walls. Culverts are anticipated to be installed late July.

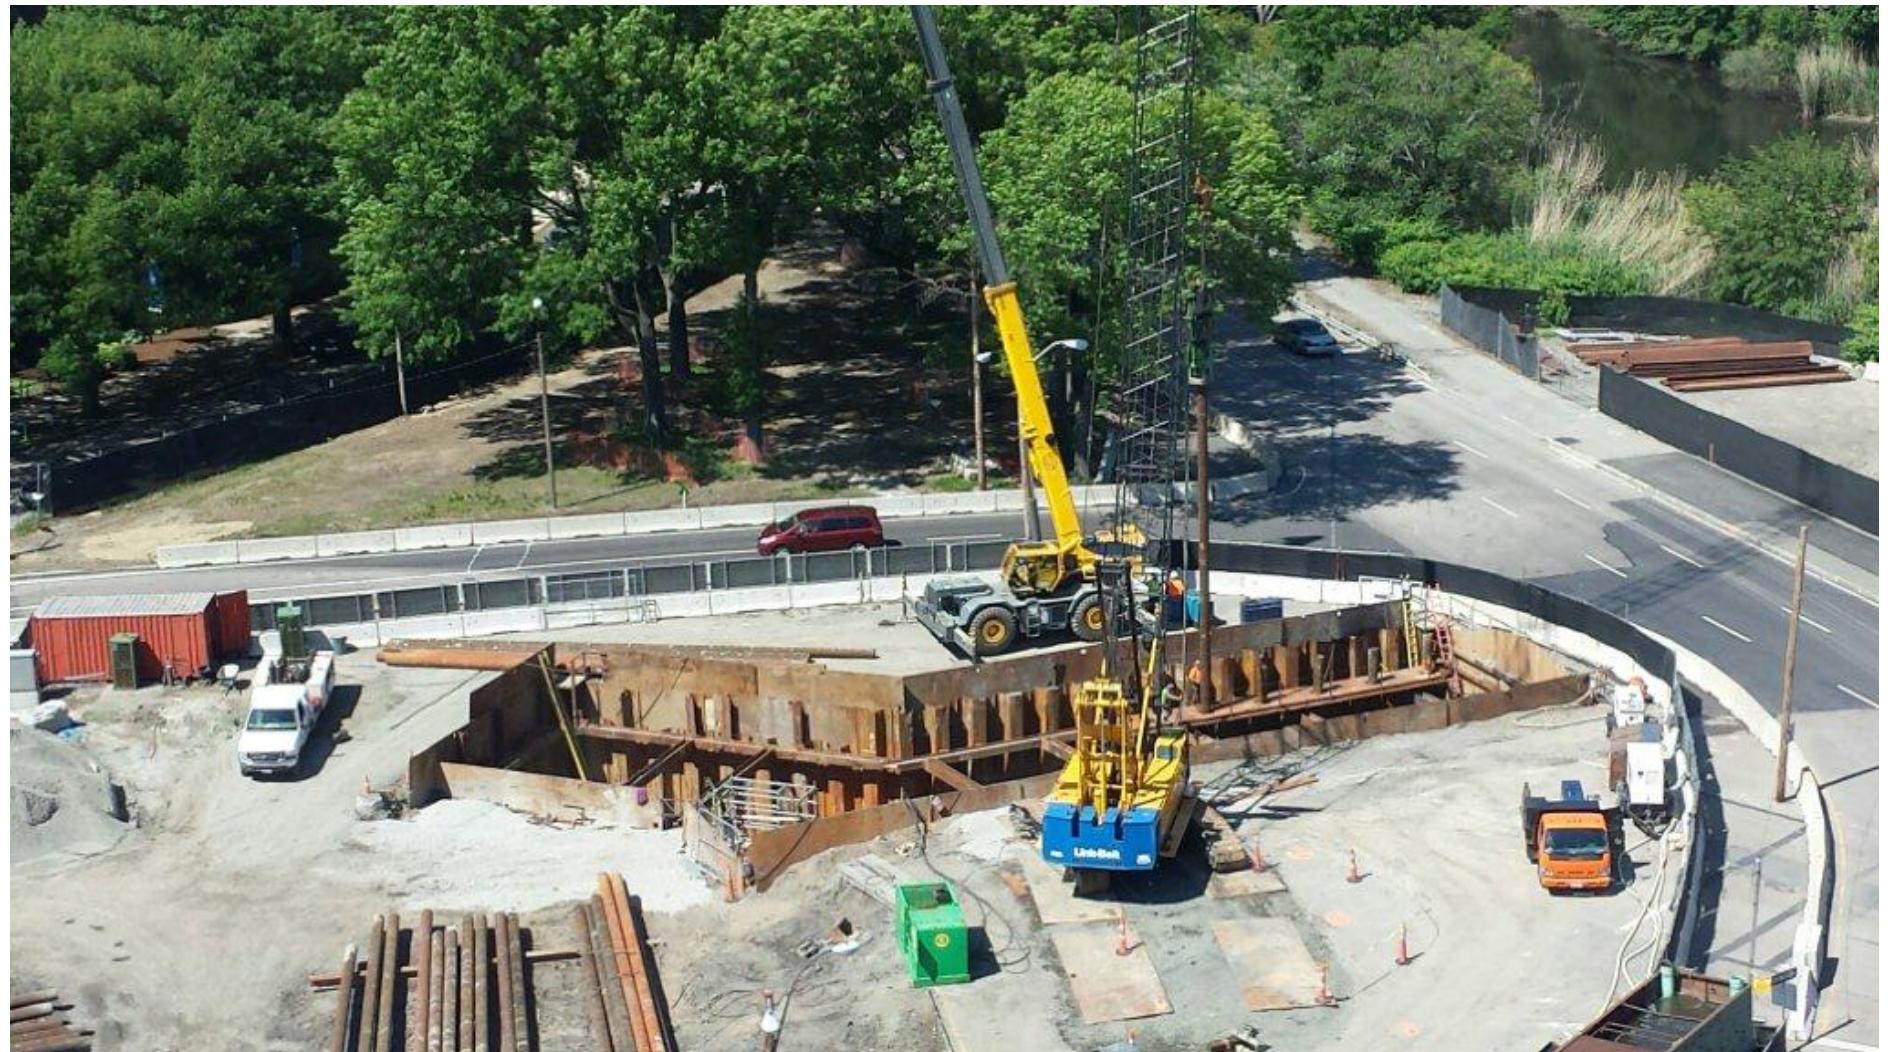
Aerial photo of the former Sears Parking Lot. Note the pipe pile installation for the Riverway culvert construction – early June 2015.

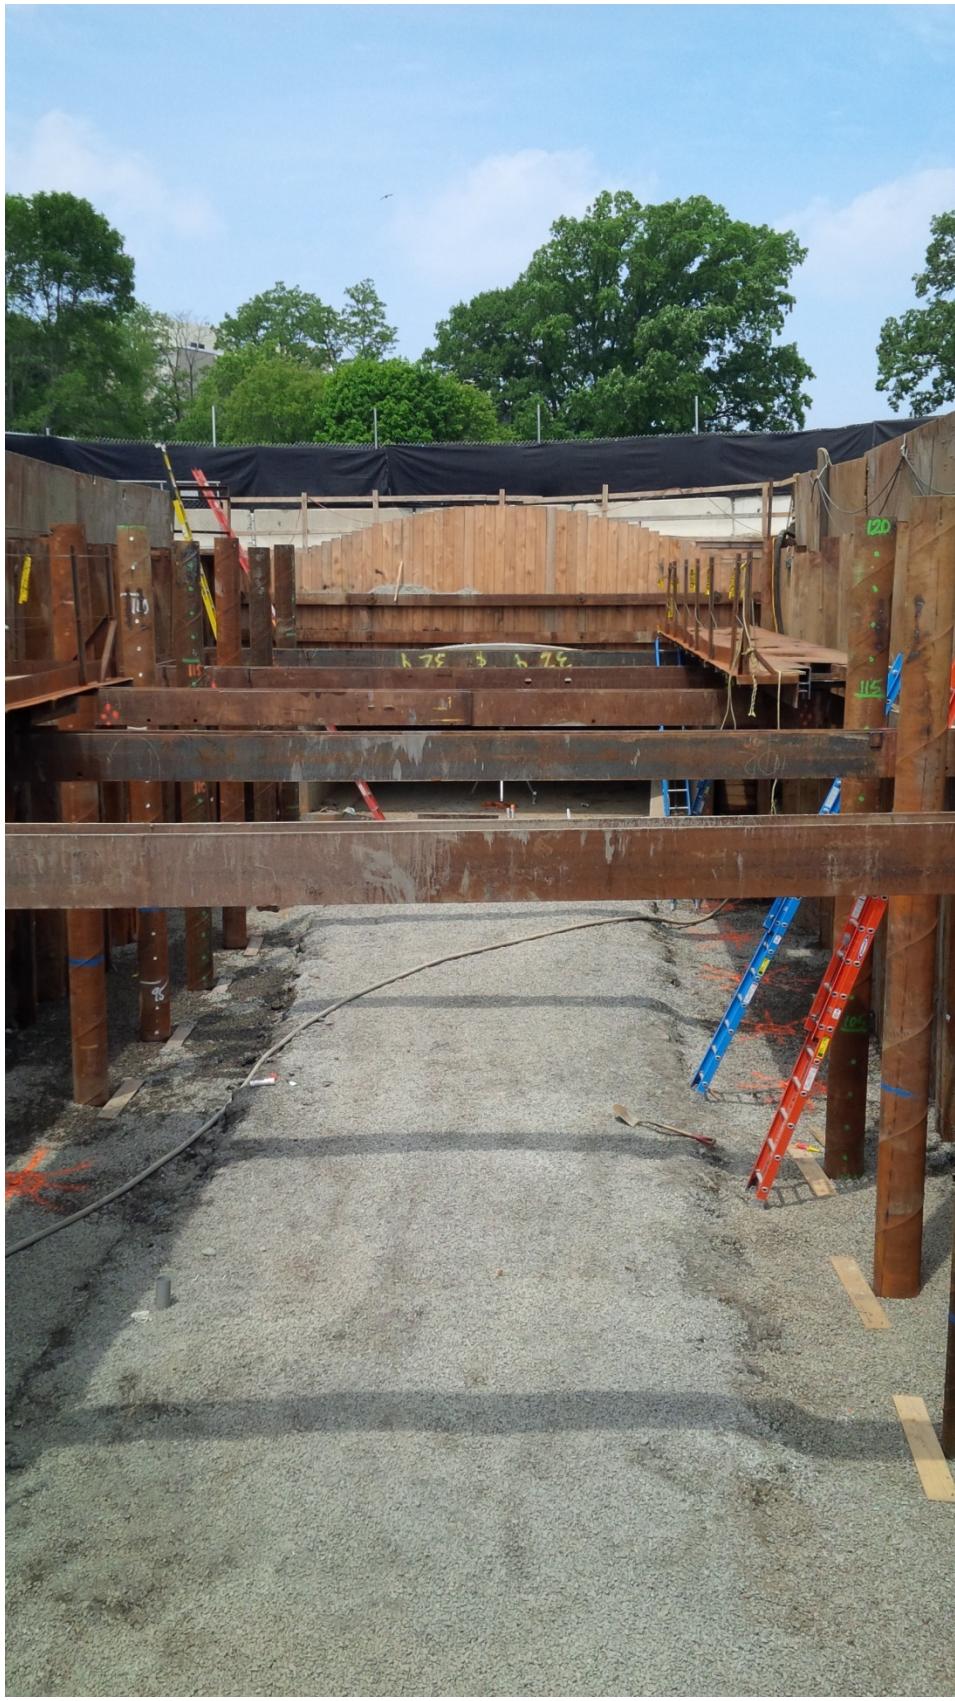
Vertical pipe piles installed for the new Riverway culvert – end June 2015.

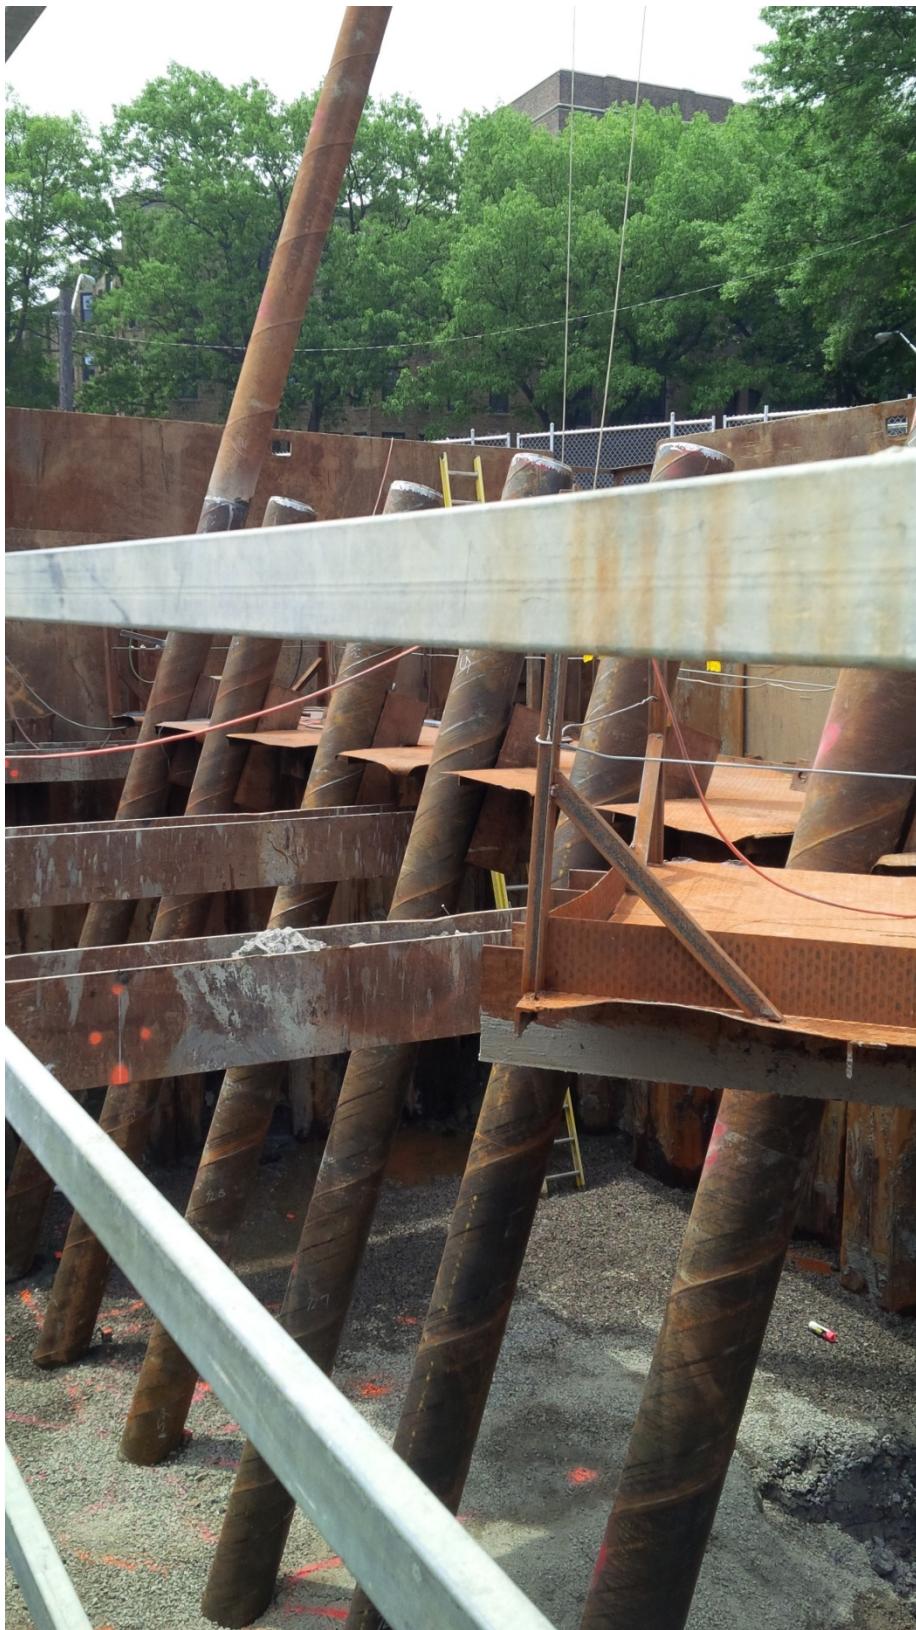
Battered (angled) pipe piles at the wing wall location for the new Riverway culvert – early June 2015.
